Manhole Inspection Summary

Manhole # S45C2_003MH

Location Address: **3625 Everett St** Cross Street: **Fairhaven Ave.**

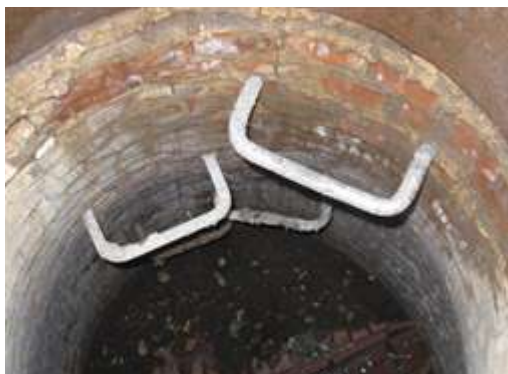
Steps Count: **4** Missing: **0** ☐ Corroded

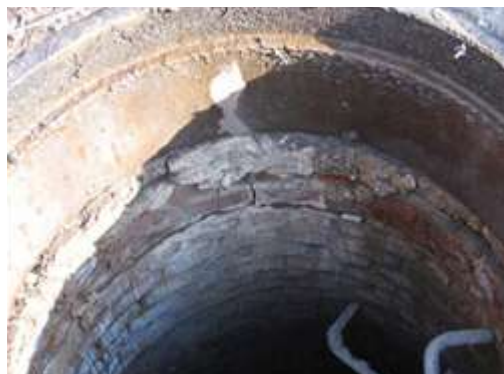
Defect 1

Frame Offset: **0.5** (in.) Condition: ☒ Sound ☐ Cracked ☐ Leaks

Chimney / Frame Adjustment ☒ Exists Material: **Brick** ☐ Parged Height: **16** (in.)
Condition: ☒ Sound ☐ Cracked ☐ Root Intrusion ☐ Loose Brick ☐ Deteriorated
Infiltration: ☐ None ☐ Joint ☒ Cracks ☒ Mortar ☐ Roots ☐ Wall

Frame offset/ cracks

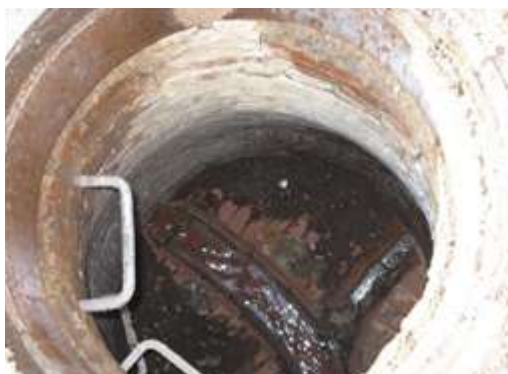
Defect 2

Debris

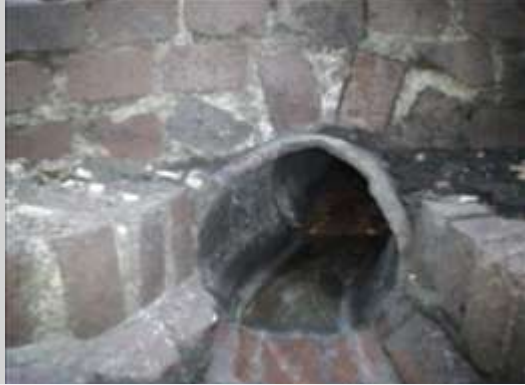
12 O'Clock Outflow

Pipe Height: **9.6** (in.) Rod and Bar (Angled)
Pipe Material: **Clay** ☐ Pipe Lined
Invert Depth: **8.23** (ft.) Flow Characteristics: **Fast**
Deposits: ☒ None ☐ Mud ☐ Sludge ☐ Debris ☐ Grease
Silt Depth: (in.) Deposits Extent:
Infiltration: **None** Pipe Seal Cond: **Sound**

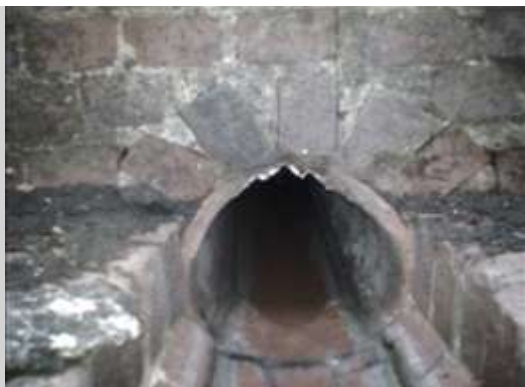
5 O'Clock Inflow

Pipe Height: **10.8** (in.) Rod and Bar (Angled)
Pipe Material: **Clay** ☐ Pipe Lined
Invert Depth: **8.16** (ft.) Flow Characteristics: **Fast**
Deposits: ☒ None ☐ Mud ☐ Sludge ☐ Debris ☐ Grease
Silt Depth: (in.) Deposits Extent:
Infiltration: **None** Pipe Seal Cond: **Cracked**

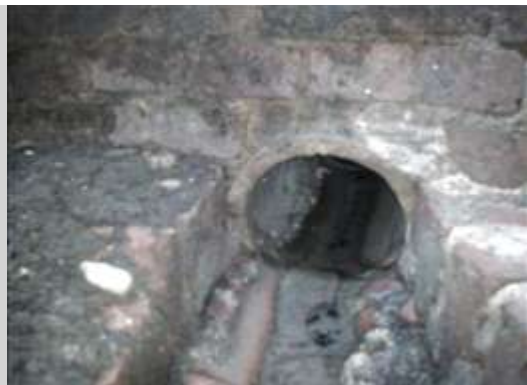
9 O'Clock Inflow

Pipe Height: **7.2** (in.) Rod and Bar (Angled)

Pipe Material: **Clay** ☐ Pipe Lined

Invert Depth: **7.81** (ft.) Flow Characteristics: **None**

Pipe Seal Cond: **Sound**
